RCRA Facility Assessment UNO-VEN, Chicago Refinery ILD041550567 1978030004 -- Will County Log No. B-162

Illinois Environmental Protection Agency
Bureau of Land
Permit Section
Corrective Action Unit
September 1996

I. EXECUTIVE SUMMARY

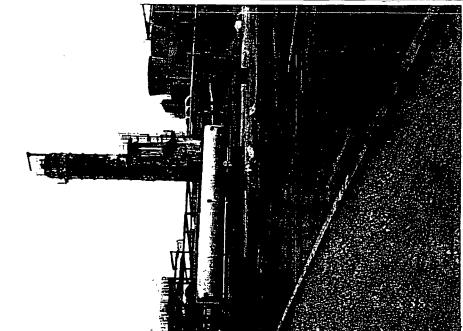
ROLL#: A PHOTO#: 12

DATE: 09/03/96	SITE #: 197803000 4 CO:: W:11
TIME:	ISITE NAME: UND-VEN, Chicogo Refinery
PHOTOGRAPH TAKEN	FILE:
BY: Pon Rybolt	
PICTURE TAKEN TOWARD: West	
COMMENTS: SWMU # 24 Former API Separator	
RÖLL#: À	
PHOTO #: 13

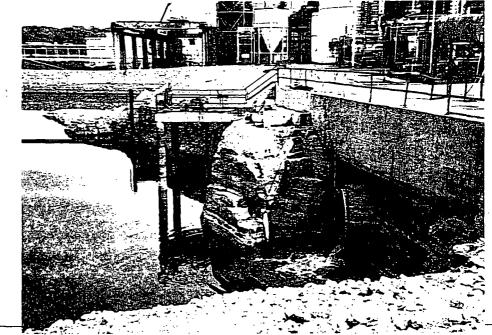
ROLL#: A
PHOTO#: 15

COMMENTS: 5wmu# 22 Fast Basin
